TECHNICIAN TIMES

Volume 5 Issue 2

2002

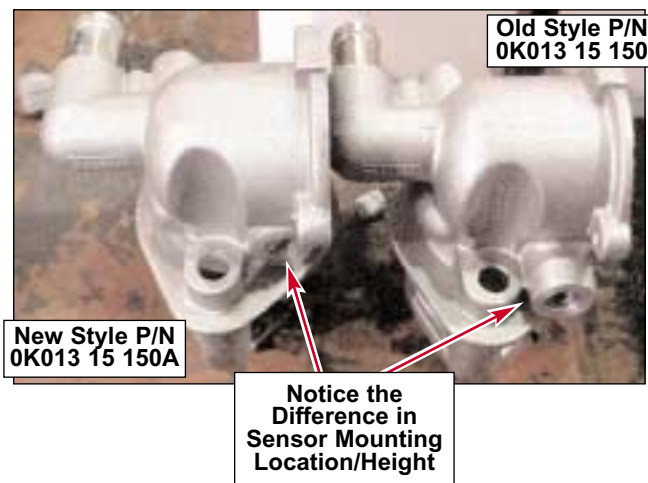
Sportage Thermostat Housing

Note the difference in sensor mounting boss (height) between the old and the new parts. The new thermostat housing causes the tip of the ECT sensor to protrude further into the coolant flow, resulting in a more responsive and more accurate temperature reading.

Do not use the old style thermostat housing on Sportages built after 9/18/00 as under certain circumstances the ECM may inadvertently set a DTC P0128 (thermostat malfunction) due to perceived slower temperature changes.

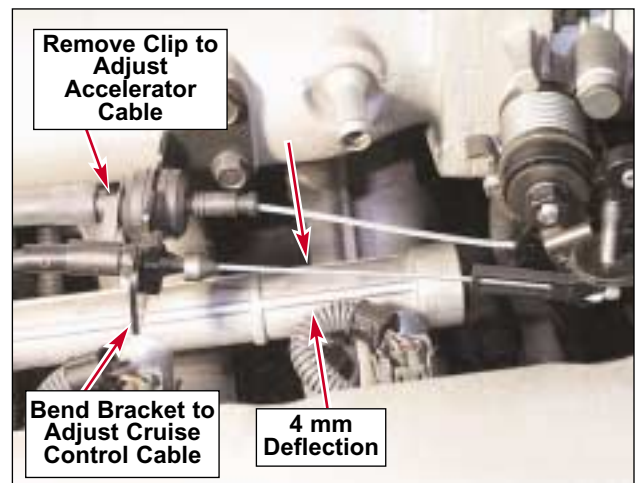
2002 Spectra P0121 Code

When servicing a 2002 Spectra with a P0121 code (TP Sensor Circuit Range/Performance Problem), make sure the cruise control cable is properly adjusted. Even though no other drivability symptoms exist, the cruise control cable bracket that bolts to the intake manifold may have been bent during other servicing making the cable too tight. To adjust the cruise control cable, bend the bracket towards the throttle body until you get approximately 4 mm cable deflection. After adjusting the cruise control cable, check the accelerator cable deflection and adjust if necessary to 4-7 mm by removing the clip at the cable retainer and moving the cable casing in or out of the retainer.

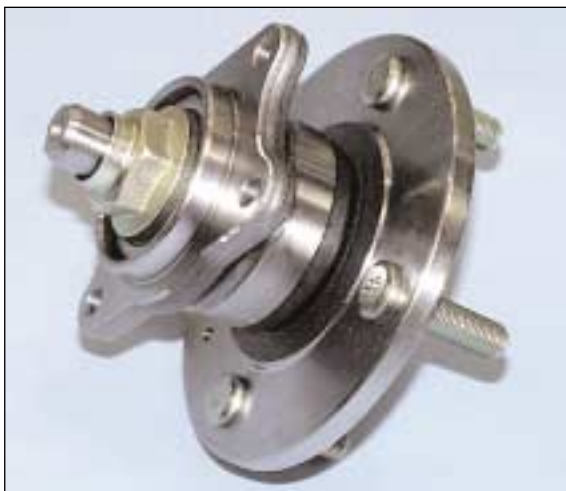
Old Hub and Bearing Assembly

To prevent bearing contamination from outside elements, the non-ABS rear hub and bearing assembly has been improved as of 5/3/01 production. The new hub has a longer boss where the assembly bolts to the rear axle carrier and a dust cap has been added as a secondary seal. Despite the visual differences, the new assembly is a direct replacement for the old assembly.

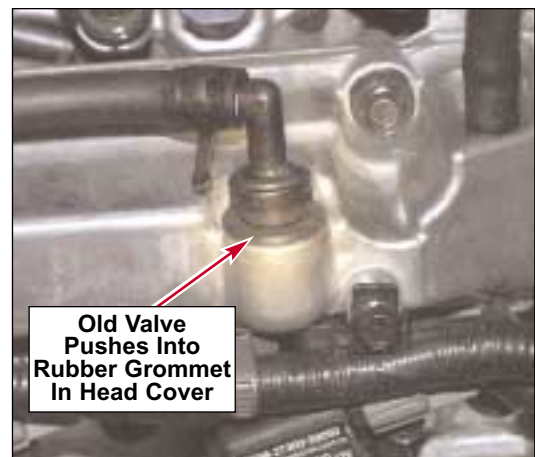
Old PCV Valve

A change has been made to the PCV valve and cylinder head cover on the '02 Sedona for improved crankcase sealing. From June 2001, the PCV valve was changed from a push-in rubber grommet type to a threaded type.

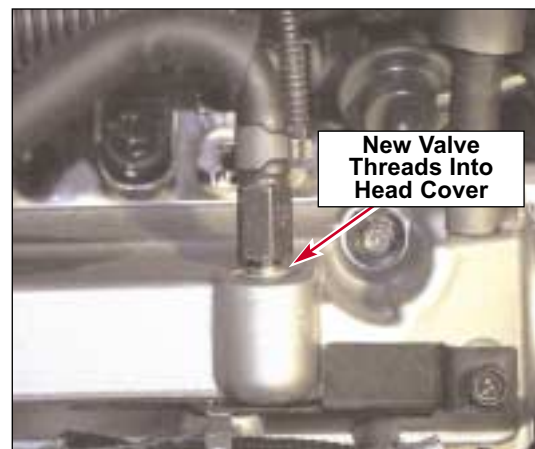
New PCV Valve

The part number for the new (threaded) PCV valve is 26740 32804. The next edition of the Sedona Parts Catalog should reflect this change and have the part number for the threaded cylinder head cover.

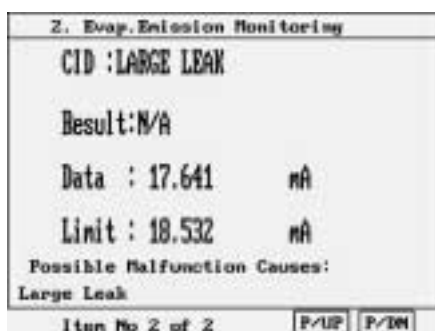
Large Leak Failure, Current Draw is Lower Than Limit

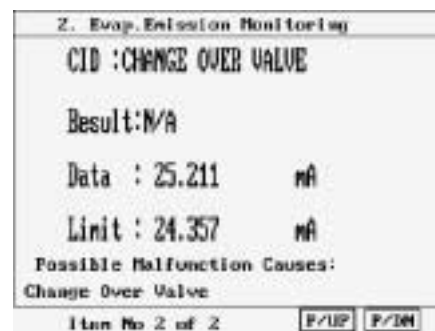
With DM-TL Hose Pinched, Current Draw is Higher Than Limit

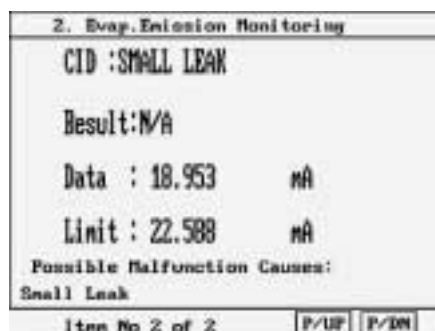
Small Leak Failure, Current Draw is Lower Than Limit

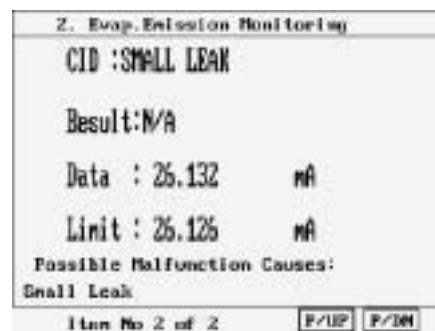
Passed Test Result, Current Draw Reached Limit
